CAPSIZING/SWAMPING ACCIDENT INVESTIGATIONS FOR 1975 SEASON.(U)

Report No. CG-D-17-77

CAPSIZING/SWAMPING
ACCIDENT INVESTIGATIONS FOR
1975 SEASON

FINAL REPORT

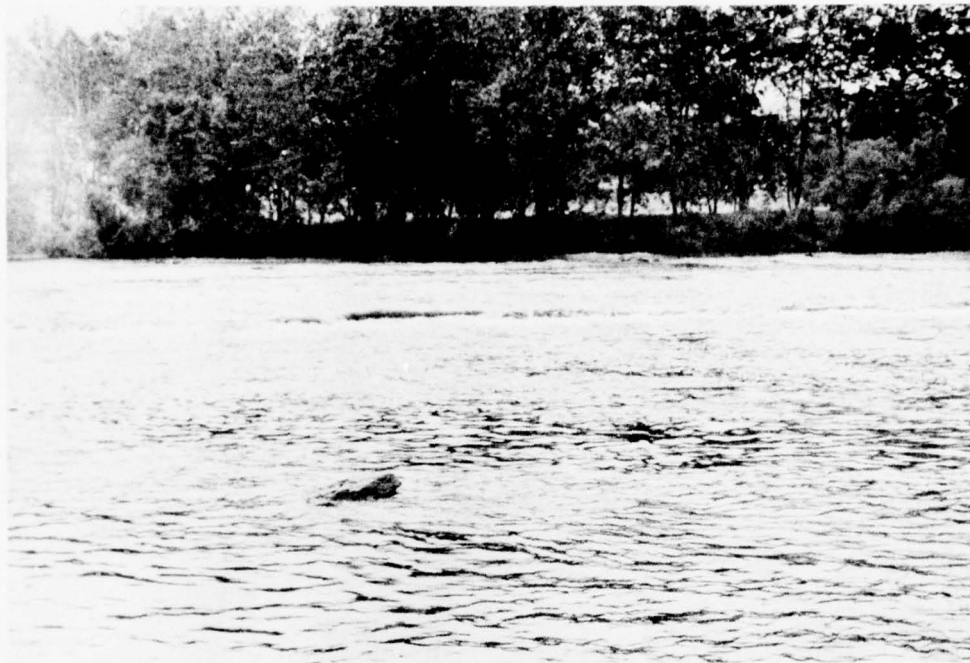
Photograph 1. Accident Site

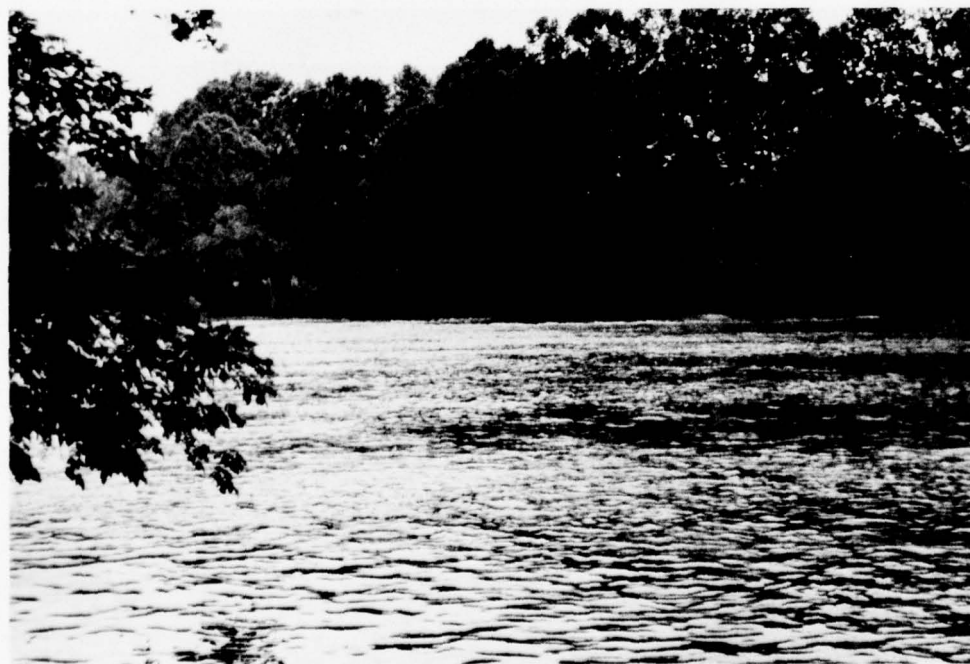
Photograph 2. View from Launch Area Toward Accident Site

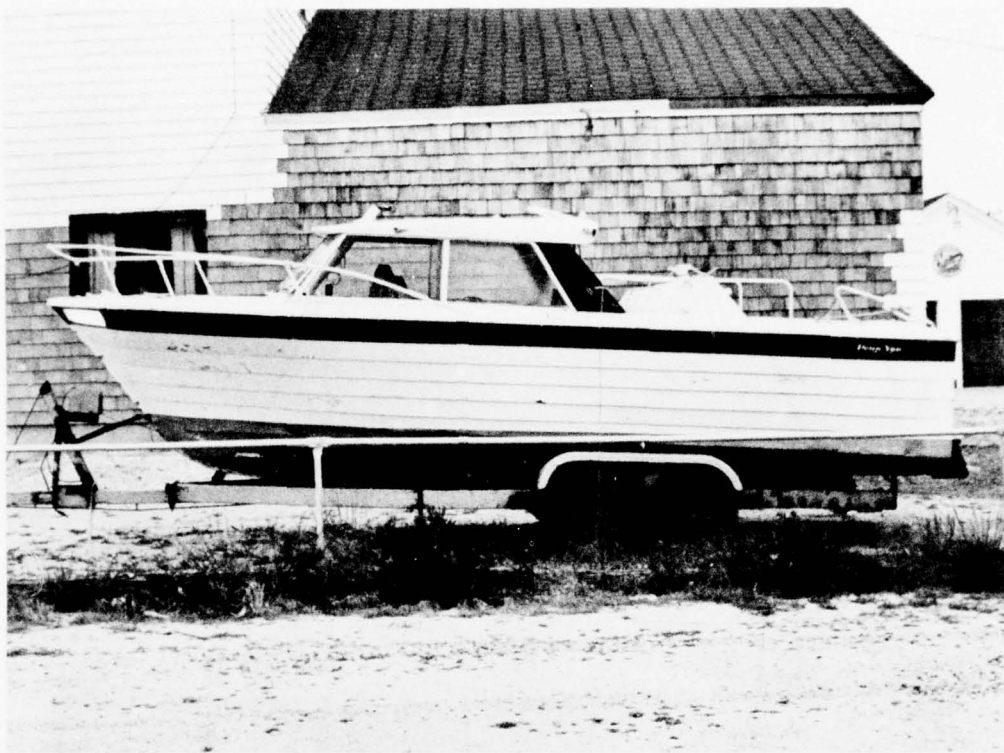
Figure 3. Profile

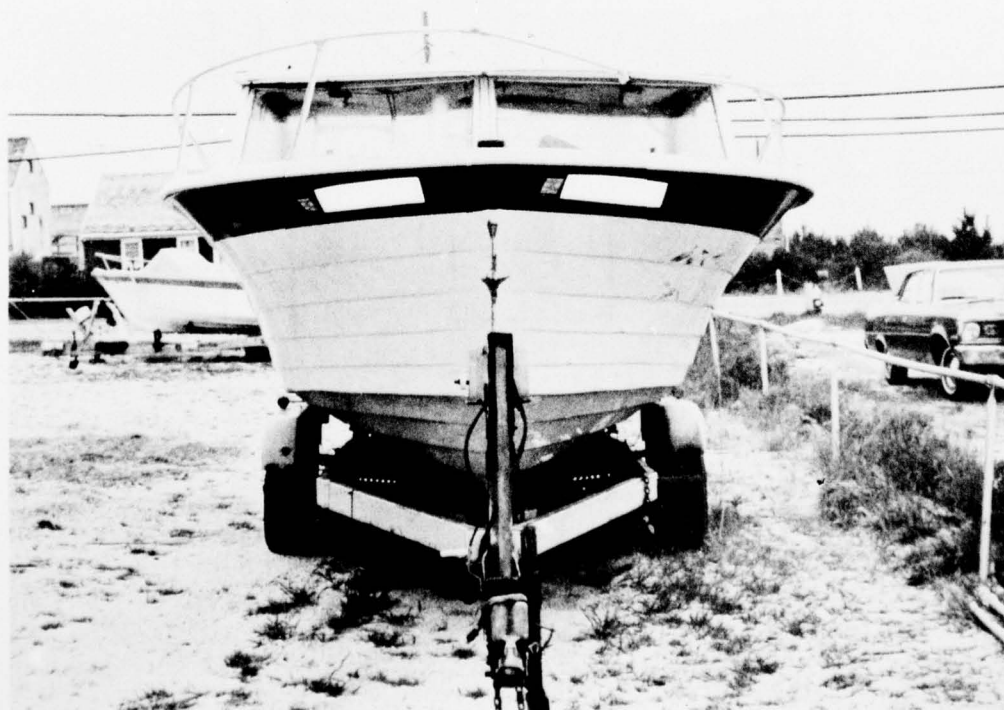
Figure 4. Bow

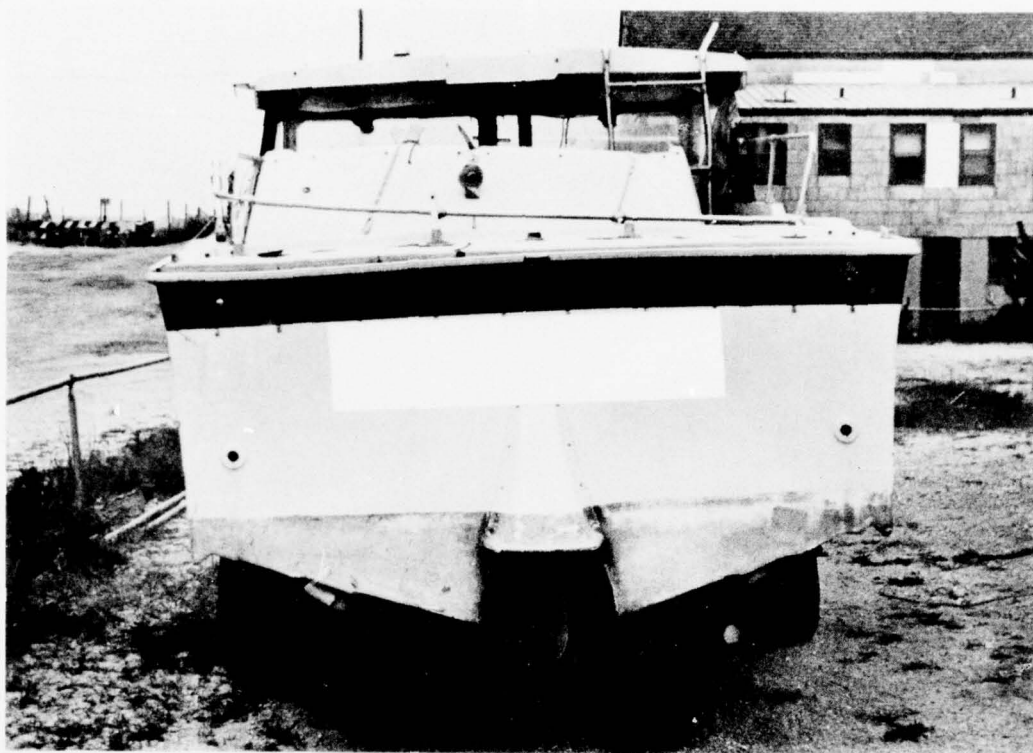
Figure 5. Stern

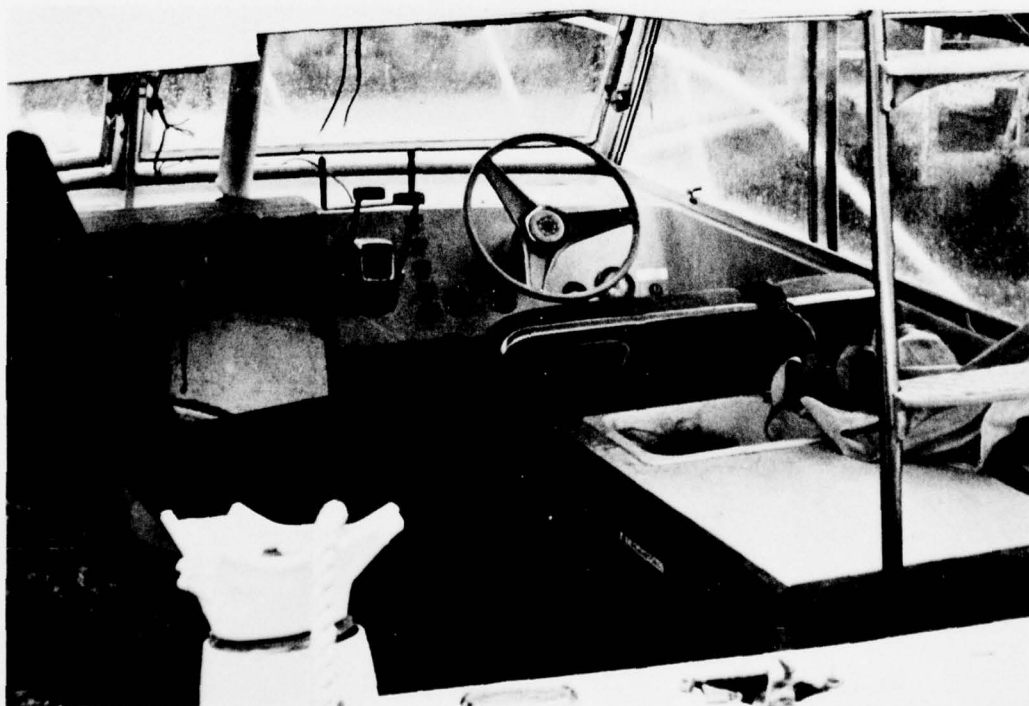
Figure 6. Cabin And Lower Control Station

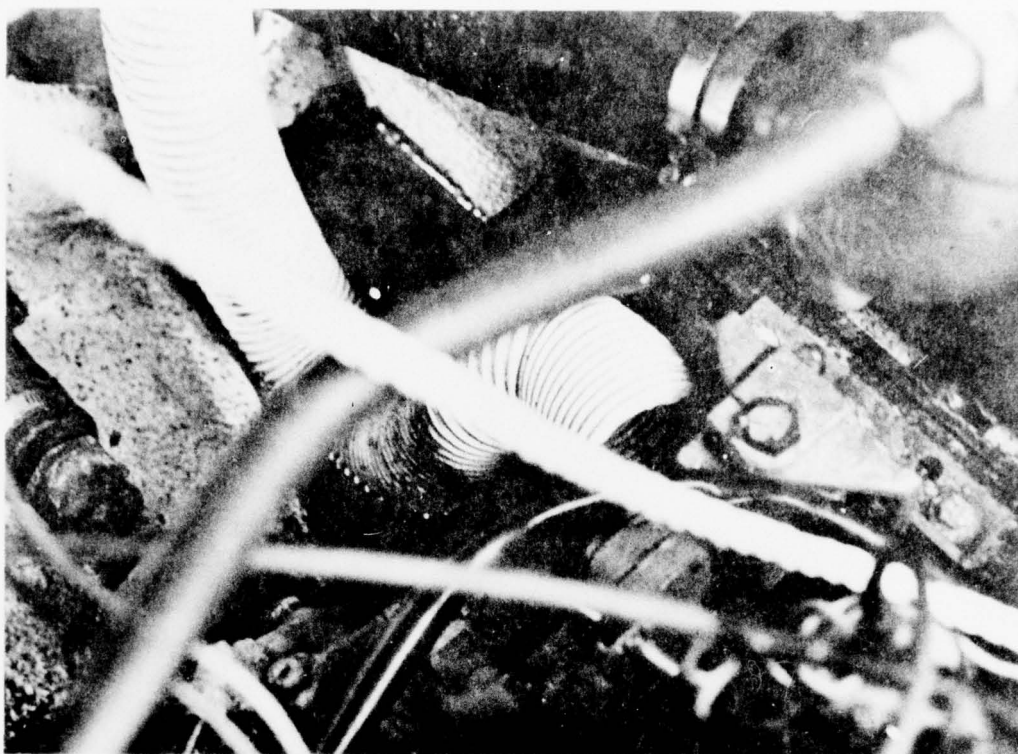
First, the blower hose looped down into the depths of the bilge then back up to the top of the stringer where it was secured with a plastic cable clamp. Water can fill the lowest portion of the hose and remain there unnoticed for the life of the boat. When this happens it renders the blower useless (see Figure 7).

Figure 7. Blower Intake Hose - Note Loop That Can Catch And Hold Water

The first two problems could be remedied by regulation if they are found to occur frequently. The third could be attacked by regulation or education.

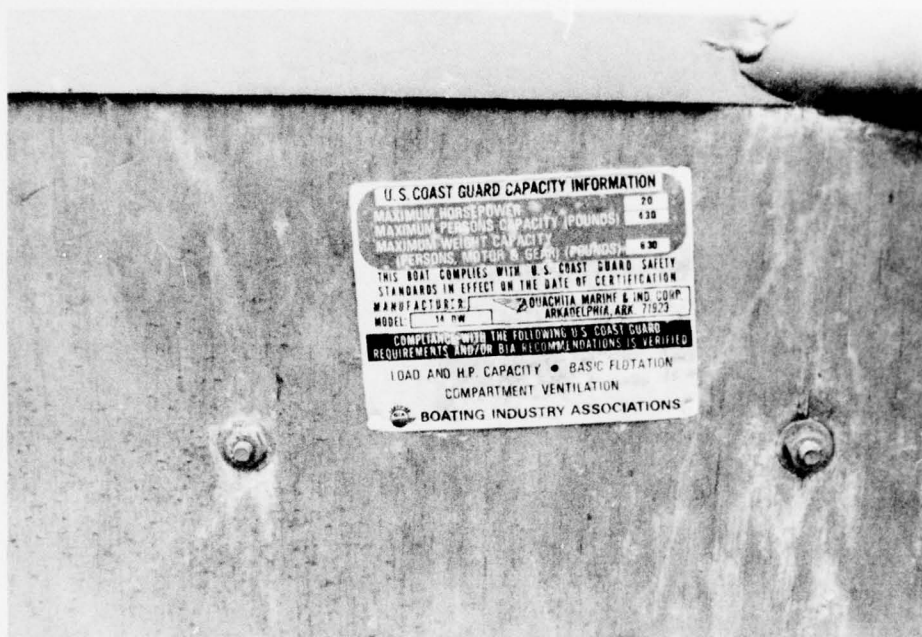
PHOTOGRAPH 9. CAPACITY PLATE ATTACHED TO BOAT

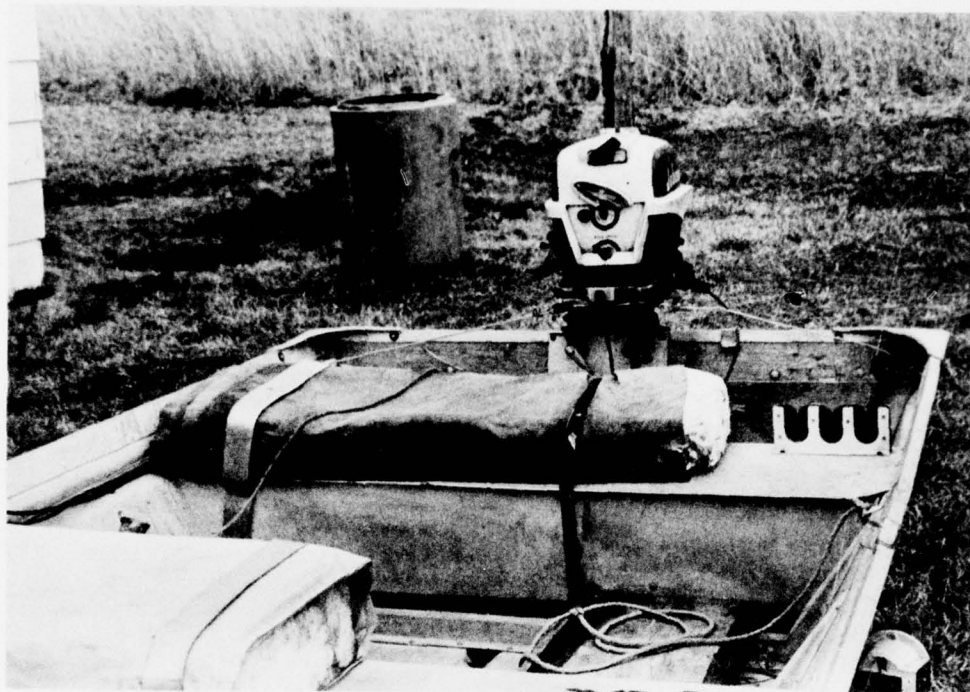
PHOTOGRAPH 7. STEERING CABLE ROUTING
